## Memorandum

To	Wendy Goodfriend, BCDC	Page	1
CC	Claire Bonham-Carter, AECOM		
Subject	Bay Farm Island Focus Area		
From	Jeremy Mull, P.E., Michael Mak, P.E., Kris May, Ph.D., P.E.		
Date	June 25, 2014

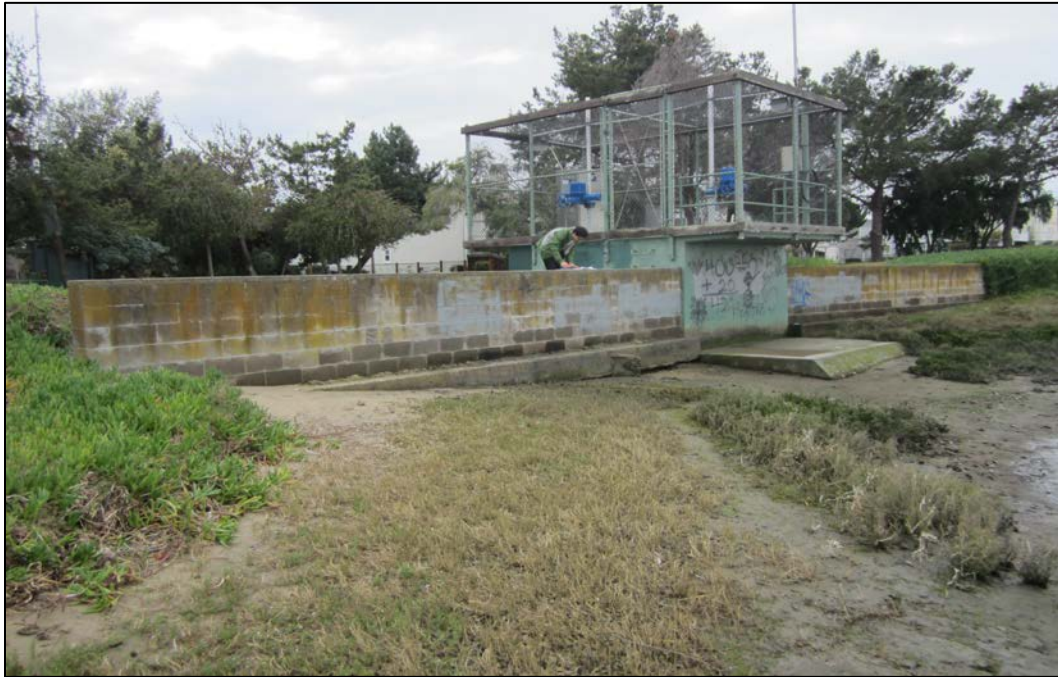
**Figure 4. Site A – Tide Gate Structure west of the Doolittle Road/Bay Farm Island Bridge**

Site A is a tide gate structure with low wing-walls located nearly 0.3 miles west of the Doolittle Road/Bay Farm Island Bridge (Figure 4). The berm behind the tide gate structure and wing-walls is at a lower elevation than the top of the wing-walls and the adjacent shoreline. The wing-walls are an engineered structure which protects the backshore area and lagoon from wave action. It also

protects the backshore area from scour during periods of discharge from the lagoon. Overtopping at this location will expose the adjacent residential neighborhood to flooding, and during permanent inundation above the wall, the discharge point for stormwater runoff out of the lagoon will be eliminated.

The wing-walls consist of two segments which are constructed approximately 2 feet above the backshore ground elevation. The average DEM elevation of the west segment was 10.0 feet NAVD88, and overtopping was expected to begin occurring at 36 inches of SLR based on the initial inundation maps. The average DEM elevation of the east segment was 9.0 feet NAVD88, and overtopping was also expected to begin occurring at 36 inches of SLR. The average LiDAR elevations of the walls are approximately 9.5 feet NAVD88, so low DEM elevations on the east segment were modified to reflect this elevation. The low-lying elevations of the backshore area on the DEM were verified to be represented correctly and were not adjusted. After modifications to the topographic DEM were completed, the inundation maps were revised using the new DEM. The new inundation maps in Attachment A show that the east section of the wing-wall is still expected to be overtopped at 36 inches of SLR (approximately 9.6 feet NAVD88). The overtopping potential lines on the inundation maps do not show overtopping over both segments of the wing-wall until 48 inches of SLR. The original DEM elevations, average LiDAR elevations, modified DEM elevations, and lowest overtopping scenarios for Site A are listed in Table 3.

Inundation of the residential areas adjacent to the lagoon will begin at 36 inches of SLR. Inundation will occur from overtopping of the tide gate wing-walls and also via pathways originating from the adjacent Corica Golf Course that is also flooded during this scenario. Residential neighborhoods

To provide flood protection for the neighborhoods adjacent to the Bay Farm lagoon for SLR greater than 36 inches (or comparable SLR and storm surge scenarios as shown in Table 2, the elevation of the tide gate, associated wing-wall structure, backshore berm behind the wing-wall, and adjacent shoreline should be raised by at least 1 to 2 feet (to approximately 10.5 - 11.5 feet NAVD88). The Bay Farm Lagoon serves as a stormwater retention pond during heavy rainfall events, and the lagoon water levels are typically drawn down before storms to increase the storage capacity. SLR will impact this process so to maintain this function, the entire tide gate structure should be raised. Future adaptation measures should consider the addition of pump systems to draw down the lagoon water levels. The adjacent shorelines should also be improved to provide sufficient freeboard (i.e., additional structure height above the flood hazard water level) above the design water levels (e.g., 36 inches of sea level rise and a 100-year extreme tide level). Additional benefits<sup>8</sup> can be achieved for the neighborhood communities if the structure is designed and constructed to provide protection from the 100-year extreme tide level (including waves) and then accredited by FEMA for providing flood protection.

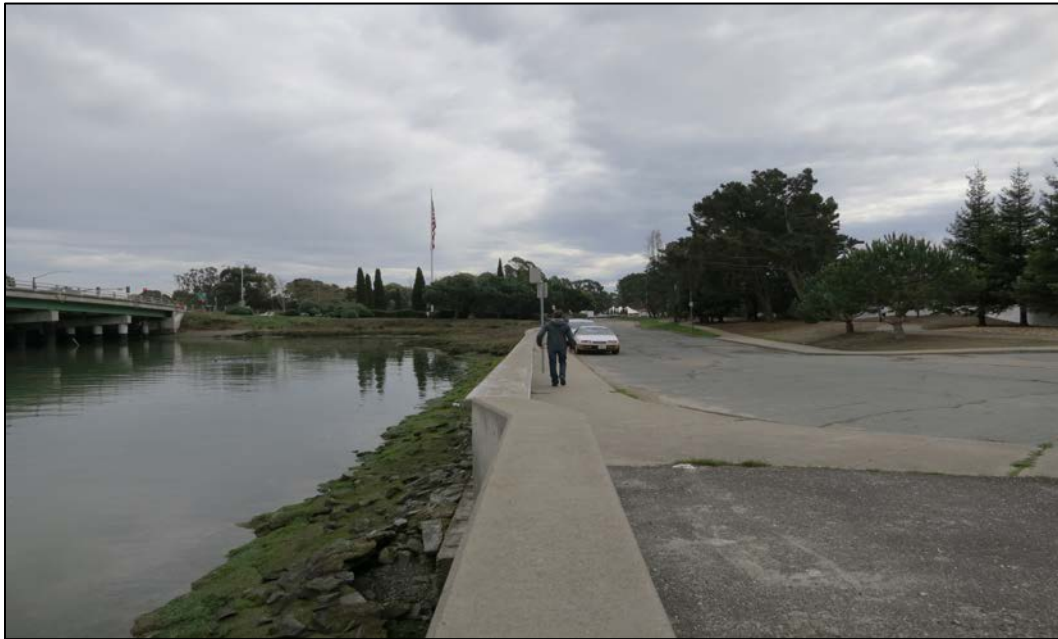
**Figure 5. Site B - Veterans Court Seawall**

Site B includes a 3 feet-high seawall located immediately west of the Doolittle Drive/Bay Farm Island Bridge along the seaward side of Veterans Court (Figure 5), and a stretch of shoreline just west of the seawall in front of the Harbor Bay Club (Figure 6) with loose rock protection from a former seawall. A detailed review of the DEM and inundation mapping in this area showed that the site served as a critical inundation pathway with 12 inches of SLR.

In the DEM, the average elevation of the north segment of the seawall was 7.2 feet NAVD88, and it was projected to begin overtopping at 24 inches of SLR based on the initial inundation maps. The average elevations of the middle and south segments of the seawall were 5.9 feet and 7.5 feet NAVD88 respectively, and they were projected to begin overtopping with 12 inches of SLR. This location is the primary pathway for all of the inundation in the Bay Farm Focus area with 12 inches of SLR under the initial inundation mapping. However, from the site visit and the initial review of the DEM, it was apparent that the elevations of the seawall were not fully captured. A review of the LiDAR data showed that the elevations at the wall are approximately 10 feet NAVD88, approximately 2.5 to 3.0 feet higher than the elevation on the DEM. To better represent the seawall, the DEM elevations at the location of the seawall were modified to reflect this elevation. The Harbor Bay Club shoreline elevations were confirmed by reviewing the topographic elevations in the DEM, and no changes were necessary. The original DEM elevations, average LiDAR elevations, modified DEM elevations, and lowest overtopping scenarios for Site B are listed in Table 3.

It should be noted that the previous inundation mapping effort demonstrated that the primary pathway for inundation of Bay Farm Island with 12 inches of SLR was over the Veterans Court seawall (Site B). Although overtopping of this seawall under an temporary extreme tide event is not likely to result

in wide-scale inundation of Bay Farm Island, overtopping due to long-term SLR could result in significant inundation. Although modifications were made to the DEM to better represent the height of this structure based on orthoimages, LiDAR data, and site visits, it is recommended that the integrity of this structure for providing flood protection be reviewed. Adaptation strategies at Site B may be the highest priority for existing and future flood protection if this structure is deemed insufficient.

The seawall at Veterans Court should be strengthened and raised to provide a higher level of flood protection. It is recommended that the seawall be raised to meet FEMA standards with sufficient freeboard (i.e., additional structure height above the flood hazard water level) to provide additional protection to accommodate future SLR. However, due to the system-wide inundation that occurs throughout Bay Farm Island with 36 inches of SLR, implementing an adaptation strategy solely for this location will not significantly reduce the overall flood risk to Bay Farm Island. A strategy at this location is needed in tandem with strategies at Site A and Sites C – G.

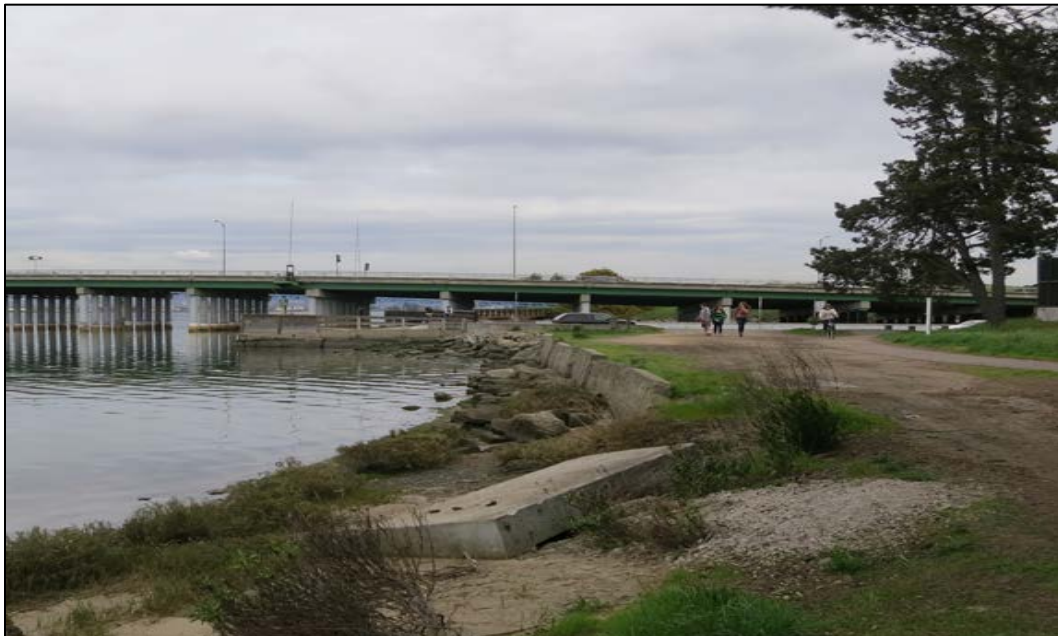
**Figure 6. Site B - Shoreline Adjacent to Harbor Bay Club Looking East at Veterans Court**

After the modifications to the DEM representing the Veterans Court area were completed and the inundation maps were updated, the new inundation maps (Attachment A) showed that overtopping of the seawall is not observed until 48 inches of SLR (approximately 10.6 feet NAVD88). However, overtopping still occurs over the Harbor Bay Club shoreline with 36 inches of SLR (approximately 9.6 feet NAVD88), and this inundation impacts the Veterans Court area and Island Drive to the south of Veterans Court.

The shoreline in front of the Harbor Bay Club should also be strengthened and raised by a minimum of 2 feet to approximately 11.0 feet NAVD88 to provide a higher level of flood protection. A higher elevation may be necessary based on freeboard criteria to meet FEMA standards. Additional wave runup analyses are necessary to determine this minimum elevation. An adaptation measure for this shoreline could include retrofitting and raising the existing seawall in addition to raising the berm along the shoreline from the seawall to a location west of the tide gate structure at Site A.

Alternatively, a living levee<sup>9</sup> could be developed for this location to provide a more natural shoreline aesthetic and valuable habitat transitioning from uplands, to marsh, to mudflat. Depending on the accommodation space available, and the desired level of flood protection, the living levee may require inland land acquisition or encroachment into the bay and existing mudflat areas. The design would also need to accommodate the wave exposure along this shoreline. This adaptation measure will require active long-term management in order to maintain an adequate level of freeboard in response to continually rising sea levels.

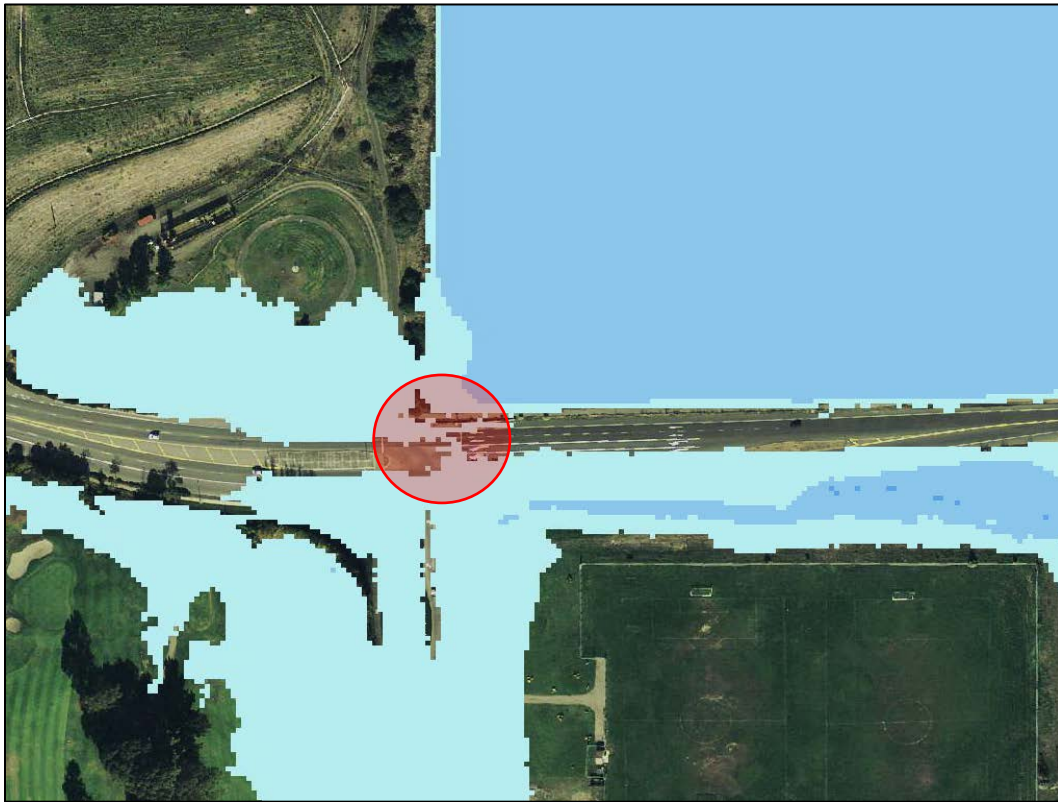
**Figure 7. Site C – Inundation Across the Intersection of Doolittle Drive / Harbor Bay Parkway**

Further review of the initial inundation maps and DEM revealed inundation pathways at three sites along Doolittle Drive with 24 inches of SLR. Site C is a section of road built on fill along Doolittle Drive at the intersection of Doolittle Drive and Harbor Bay Parkway. At the intersection, the inundation with 24 inches of SLR occurs via a flow pathway created by a single low-lying elevation on the DEM (see Figure 7). The 2-m resolution DEM had over-smoothed the crown of the road in the intersection, allowing water levels during the MHHW + 24 inch scenario to just exceed the crown and inundate the inland areas behind Doolittle Drive (see Figure 8). The average DEM elevation of the road at the intersection was 8.5 feet NAVD88. To verify the crown elevation of the road, the LiDAR data was overlaid over the DEM. The average LiDAR elevations of the street are approximately 9.0 feet NAVD88, or approximately 0.5 feet higher than the elevations identified on the DEM. The elevations in the DEM were modified to reflect the higher elevation, and the inundation maps were revised. After remapping this focus area using the modified DEM, all sections of Doolittle Drive provide flood protection up to 36 inches of SLR (approximately 9.6 feet NAVD88; See Attachment A). The original DEM elevations, average LiDAR elevations, modified DEM elevations, and lowest overtopping scenarios for Site C are listed in Table 3.

Note: A low-lying elevation on the DEM at the intersection of Doolittle Drive and Harbor Bay Parkway was found to be a pathway to inundation of inland areas during 24 inches of SLR.

Between Sites C and G, the primary flood protection element along Doolittle Drive is the roadway itself. The Bay is located to one side of the roadway, and marshlands and industrial areas are located to the other side. Many of the inland areas are at elevations below the crown of Doolittle Drive. Large sections of Doolittle Drive will be overtopped by water levels of MHHW + 36 inches and higher. Figure 13 shows an elevation profile Doolittle Drive compared to water levels associated with 12-, 24-, 36-, 48-, and 60-inches of SLR. With 24 inches of SLR, the Bay water levels at MHHW will be very near the crown of Doolittle Road, likely compromising its ability to function in its current capacity. With 36 inches of SLR, the overtopping depth along the roadway would be less than 1 foot between Sites C and F. Increasing the existing grade of Doolittle Drive by 1 foot to approximately 10 feet NAVD88, or more, and providing additional shoreline protection features to prevent erosion would provide additional protection for the inland areas from inundation and flooding. However, a strategy that considers the entire length of Doolittle Drive would be more effective at addressing the shoreline vulnerabilities in this area. To provide flood protection up to 48 inches of SLR, or a 100-year storm surge event coupled with 6 inches of SLR, some portions of Doolittle Drive would need to be elevated by 3 feet to approximately 12.0 feet NAVD88. Elevating the roadway should be coupled with shoreline improvements and habitat enhancements such as a living levee, to retain the natural aesthetic and habitat value in this area.

As an alternative to raising the elevation of Doolittle Drive, a levee or seawall could be constructed on the seaward edge of Doolittle Drive. The levee or seawall could be designed and implemented in an adaptable manner that allows the elevation to be increased over time as sea level rise and flood risks increase. However, this strategy would encroach into the bay and require wetland mitigation.

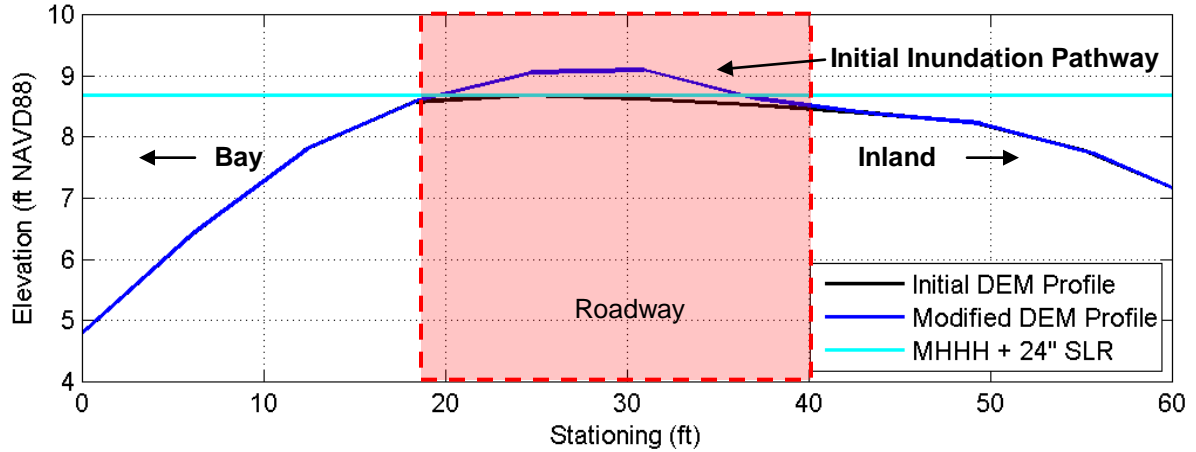
**Figure 8. Roadway Cross Section of Intersection at Doolittle Drive and Harbor Bay Parkway**

Note: The over-smoothed crown in the original DEM was allowing inundation with 24 inches of SLR (blue line).

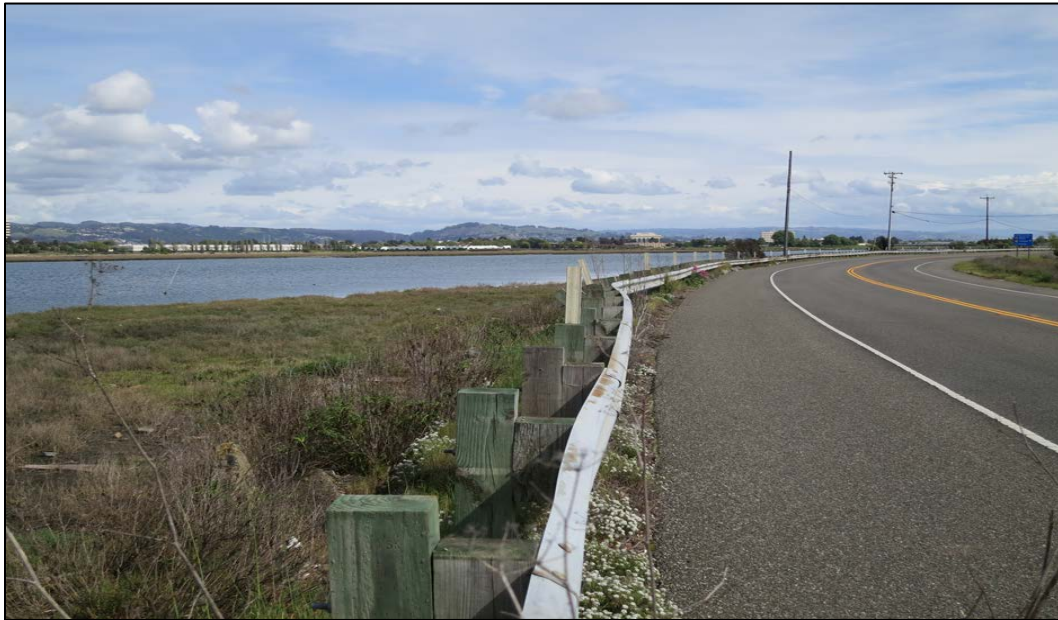
**Figure 9. Site D – Doolittle Drive Looking Southeast**

Site D is a section of Doolittle Drive built on fill approximately 0.2 miles east of the intersection of Doolittle Drive and Harbor Bay Parkway (Figure 9). At Site D, the initial maps showed inundation across Doolittle Drive during 24 inches of SLR via a flow pathway across several low-lying elevations in the DEM, similar to Site C. The 2-m resolution DEM had over-smoothed the highest elevations near the center line of the road allowing water levels during the MHHW + 24 inch scenario to inundate the island in the inundation analysis. The average DEM elevation of the road at this site was 8.5 feet NAVD88 (see Figure 10). The average LiDAR elevations of the street are approximately 9.0 feet NAVD88, so the elevations in the DEM were raised approximately 0.5 feet in this area. The revised inundation mapping for this focus area using the modified DEM shows that all sections of Doolittle Drive provide flood protection until 36 inches of SLR is reached (approximately 9.6 feet NAVD88; See Attachment A). The original DEM elevations, average LiDAR elevations, modified DEM elevations, and lowest overtopping scenarios for Site D are listed in Table 3.

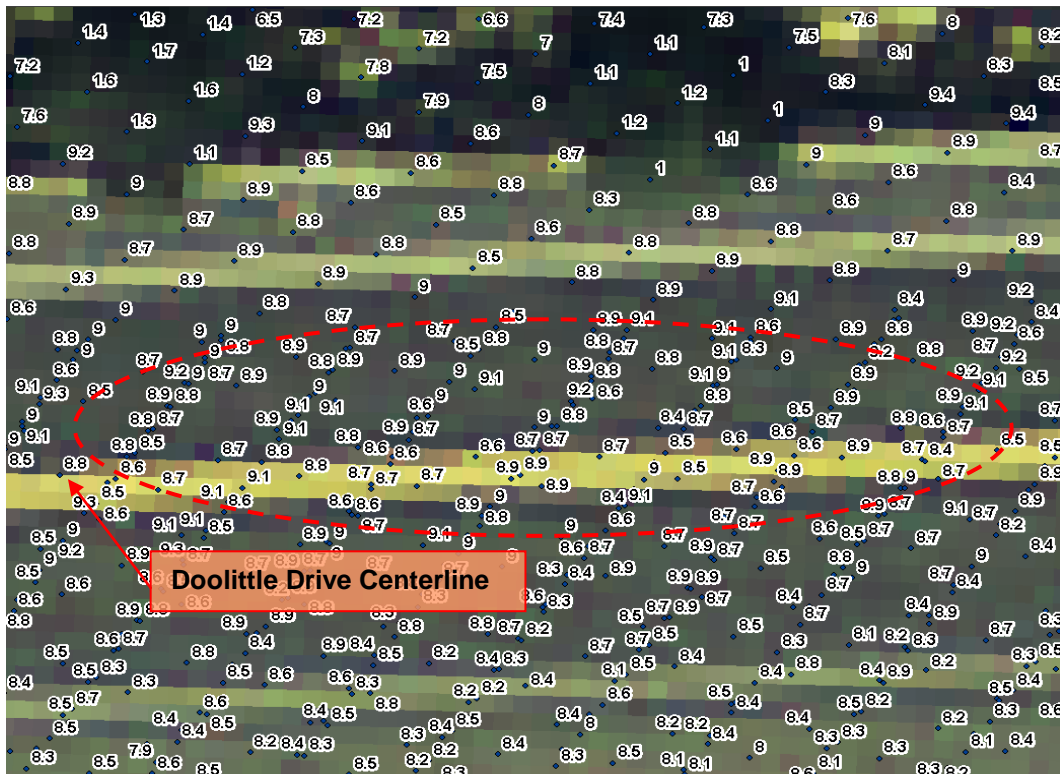
**Figure 10. LiDAR Elevations at Site D**

Note: The measured LiDAR elevations at the high point in the road are approximately 8.5-9.5 feet NAVD88. The DEM grid cells in the same locations were modified to a minimum elevation of 9 feet NAVD88.

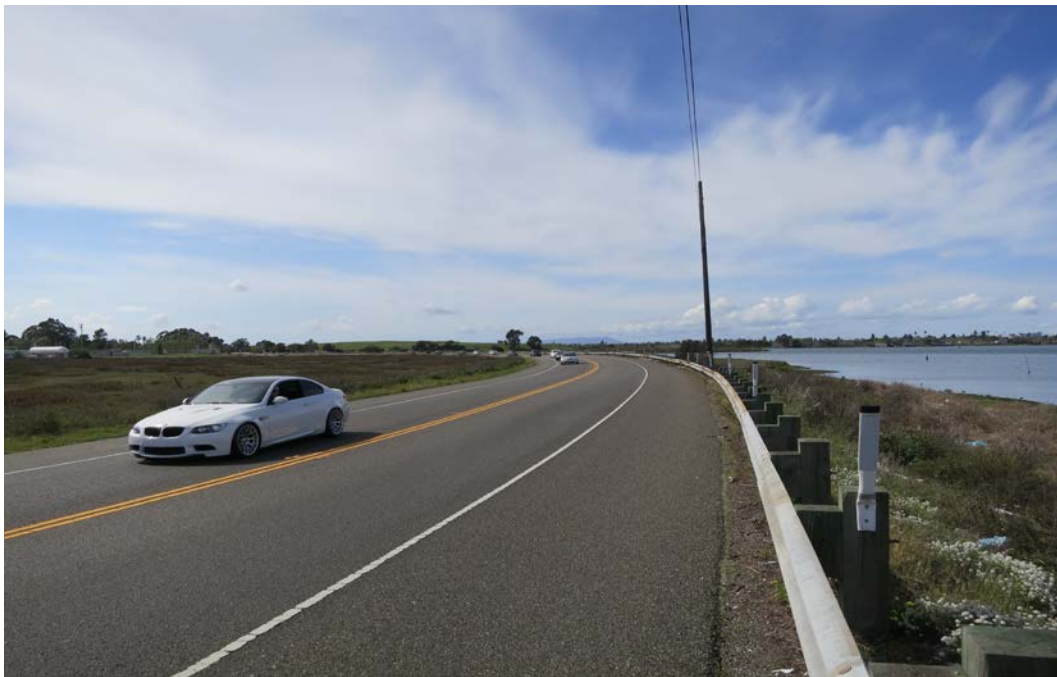
**Figure 11. Site E – South Doolittle Drive, Looking Northwest**

Site E on Doolittle Drive is a section of the roadway built on fill, approximately 0.3 miles southeast of the intersection of Doolittle Drive and Harbor Bay Parkway (see Figure 11). At Site E, inundation over Doolittle Drive with 24 inches of SLR was generated via a flow pathway across several low-lying elevations in the DEM, similar to Sites C and D. The 2-m resolution DEM had over-smoothed the highest elevation in the road allowing water levels during the MHHW + 24 inch scenario to inundate inland areas. The average DEM elevation of the road at this site was 8.5 feet NAVD88. The average LiDAR elevations of the street are approximately 9 feet NAVD88, so the elevations in the DEM were raised approximately 0.5 feet in this area. After remapping this focus area using the modified DEM, all sections of Doolittle Drive provide flood protection until 36 inches of SLR (approximately 9.6 feet NAVD88; See Attachment A). Areas further south on Doolittle Drive were also reviewed to confirm the elevations in the DEM, and no changes were warranted. The original DEM elevations, average LiDAR elevations, modified DEM elevations, and lowest overtopping scenarios for Site D are listed in Table 3.

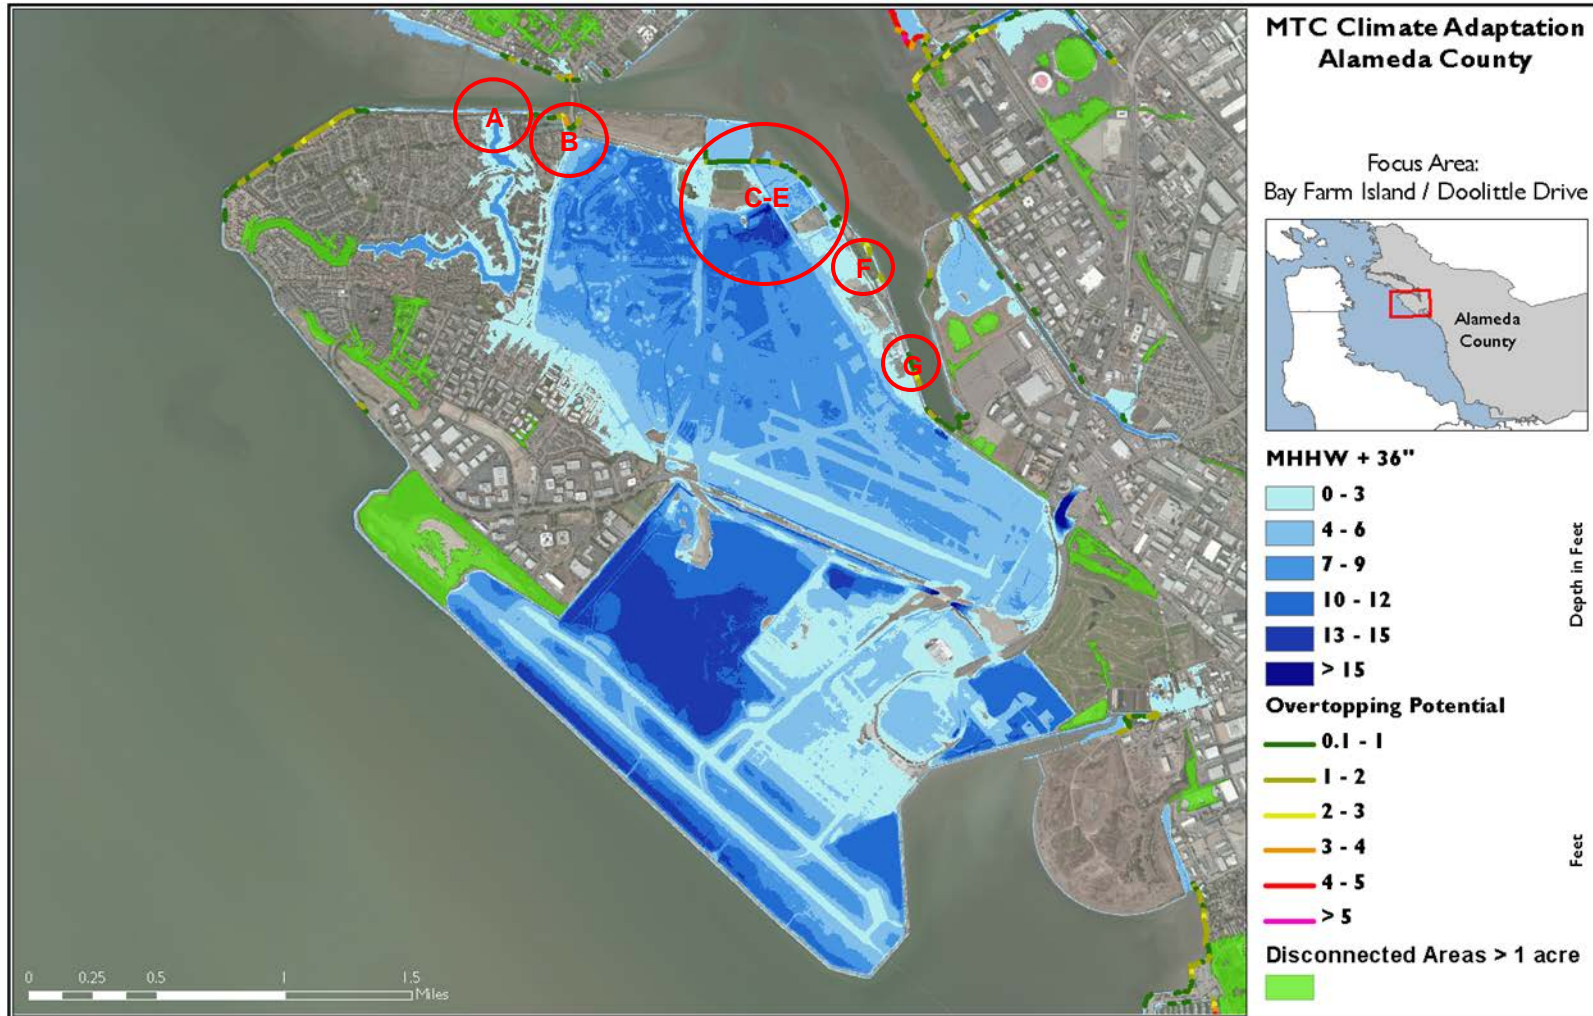
**Figure 12. Updated Inundation and Flooding Analysis Using the Modified DEM**

The initial inundation maps for the Alameda County Sea Level Rise Shoreline Vulnerability Assessment indicated that a majority of the Bay Farm Island focus area would be permanently inundated with only 12 inches of SLR. Modifications to the DEM at Sites A-E and subsequent re-analysis verified that system-wide inundation of the focus area will now first occur with 36 inches of SLR (approximately 9.6 feet NAVD88; see Figure 12). In this scenario, overtopping will occur along the low-lying shoreline just west of the Veterans Court seawall in front of the Harbor Bay Club (Site B) and along the northern and eastern sections of Doolittle Drive (Sites C-E). Overtopping at the tide gate wing-wall (Site A) will also occur with 36 inches of SLR. Two additional low areas have been identified on southeast Doolittle Drive (Sites F and G). These sites are low spots on the roadway that can serve as hydraulic connections for floodwaters to reach inland areas with 36 inches of SLR. These sites are also critical pathways to extensive inland inundation at this water level scenario. The areas along the Bay Farm Island shoreline that lead to system-wide inundation during 36 inches of SLR are shown on Figure 12.

Note: System-wide inundation of Bay Farm island is expected at 36 inches of SLR. The tide gate wing-wall (Site A), the Harbor Bay Club shoreline (Site B), and sites along Doolittle Drive (Sites C-G) are the critical inundation pathways in this scenario.

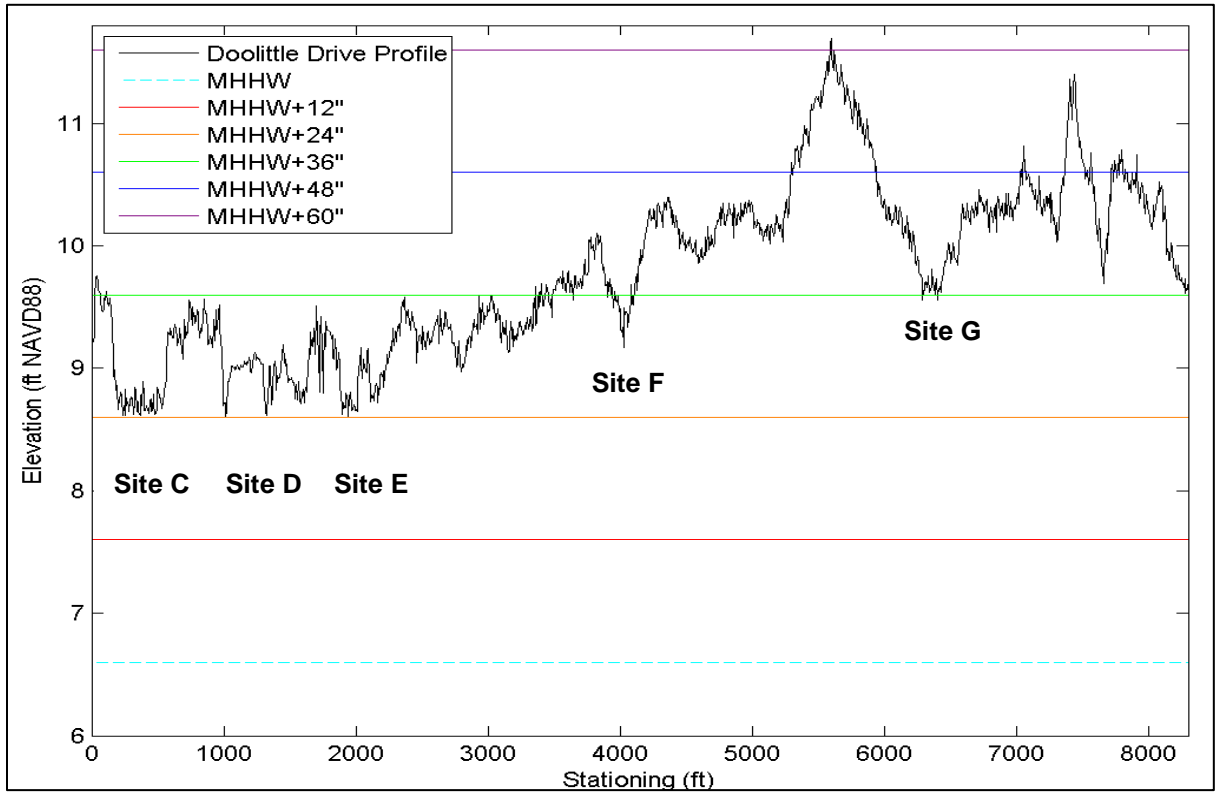
**Figure 13. Elevation Profile of Doolittle Drive with Water Level Scenarios**

Note: Significant portions of the road are first overtopped with 36 inches of SLR and equivalent flooding scenarios. Each additional foot added to the elevation of the road will increase the flood protection capacity to a successively higher water level. See Figure 12 for site locations.

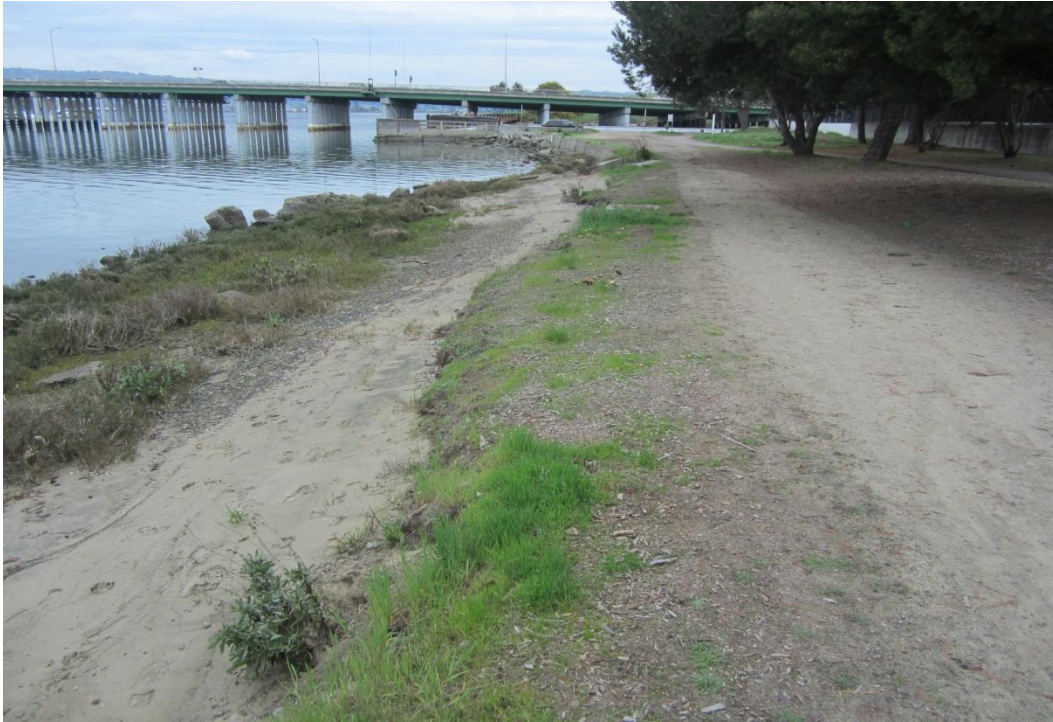
**Bay Farm Island Focus Area– Looking East along Harbor Bay Club Shoreline (Site B)**

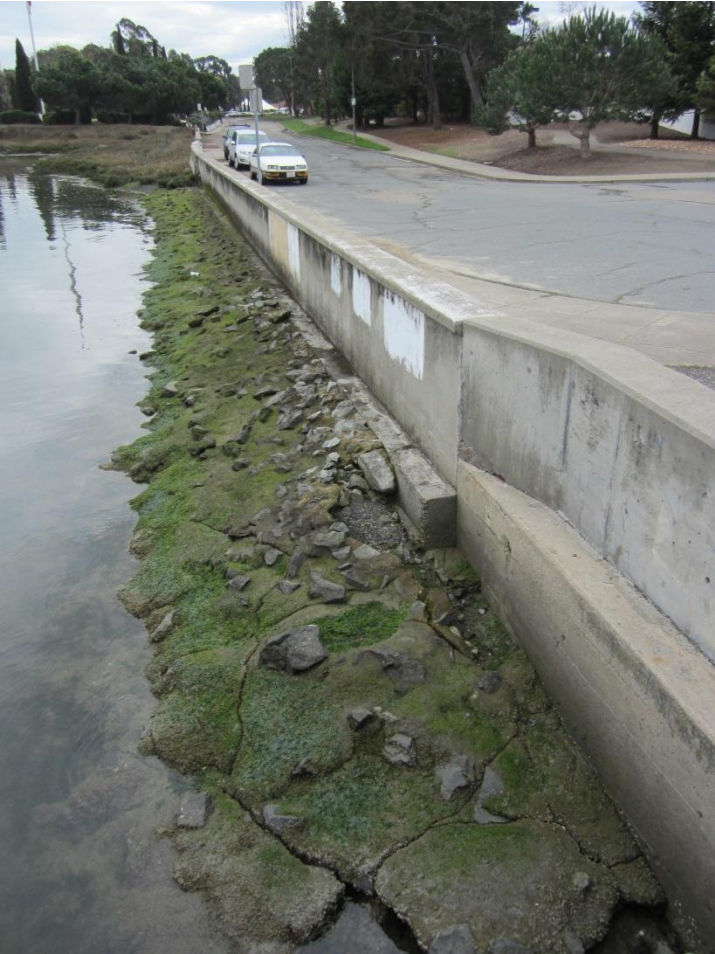
**Bay Farm Island Focus Area– Looking East along Harbor Bay Club Shoreline (Site B)**

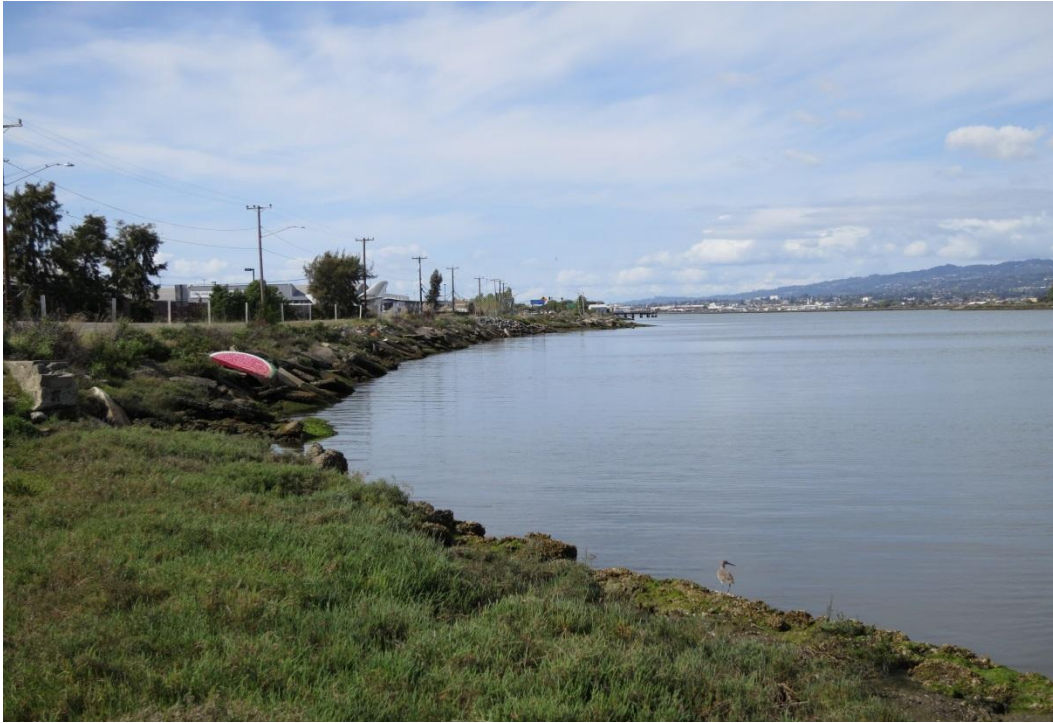
**Bay Farm Island Focus Area– Doolittle Drive Shoreline Looking North**

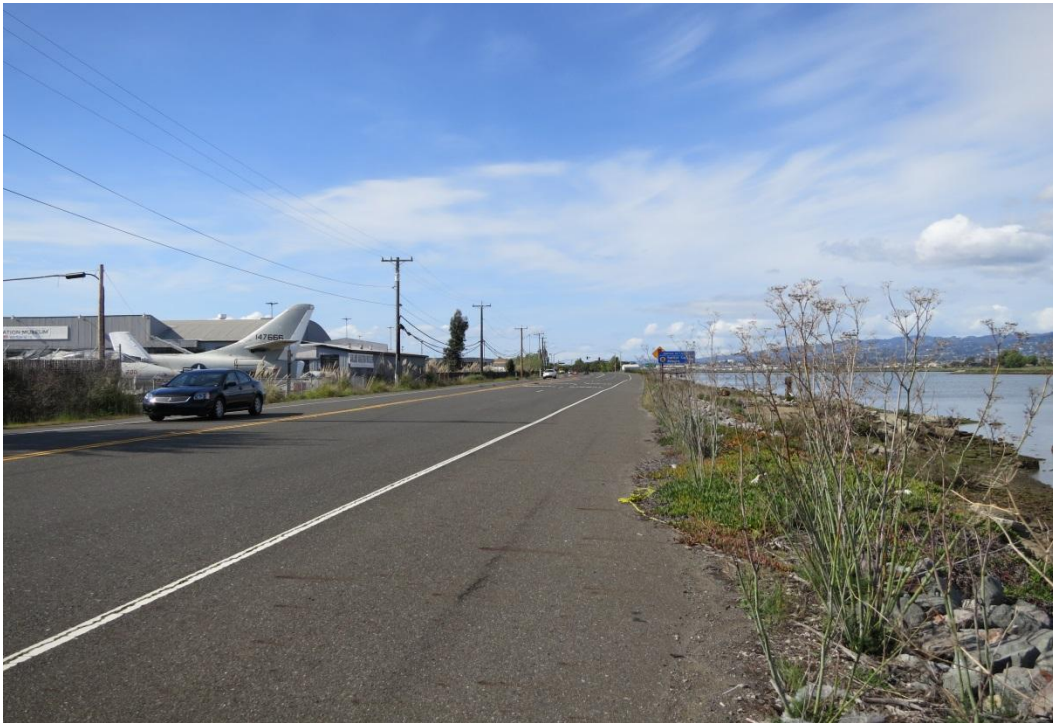
**Bay Farm Island Focus Area– Doolittle Drive Shoreline Looking North (Site G)**
