The  
Adapting to Rising Tides  
Program

Oakland/Alameda Resilience Study

## Meeting Objectives

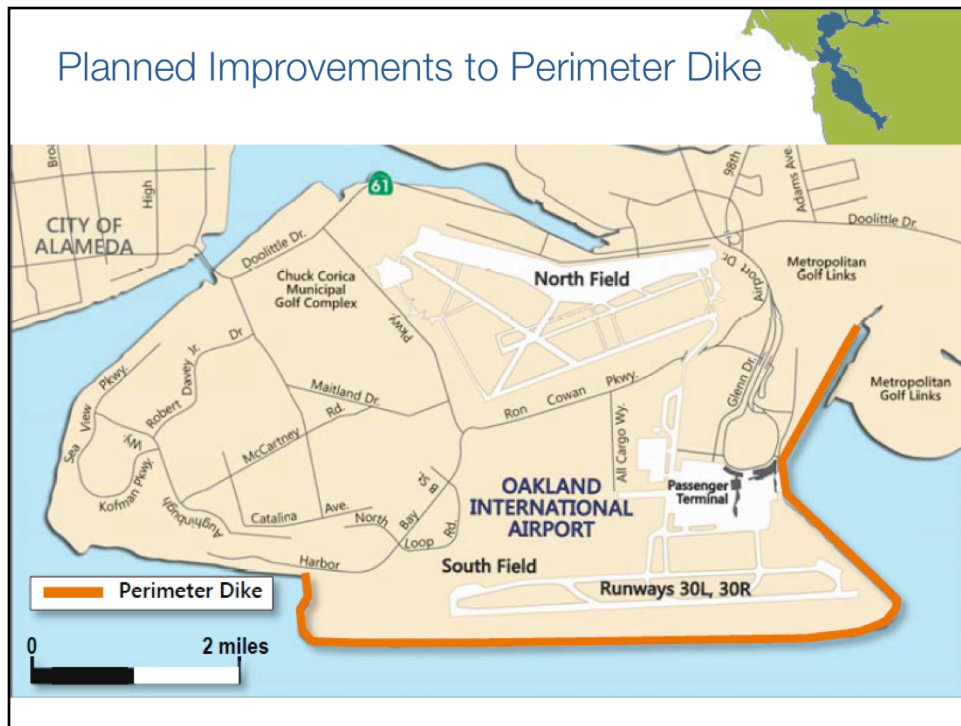
Note that South Field is protected-

Note that South Field is protected under current and near term flood levels. Planning is underway for upcoming seismic work. Planned improvements-construction starts next year

- Raise the APD to provide shoreline and flood protection against anticipated mid-century sea-level rise, tidal and storm surges.
- Improve stability and reduce water seepage of the dike by installation of new embankments, and deep cement-soil mix walls.
- Strengthen the dike against liquefaction by the installation of underground rock columns.
- Strengthen the dike against wave action by the installation of additional rock armor.

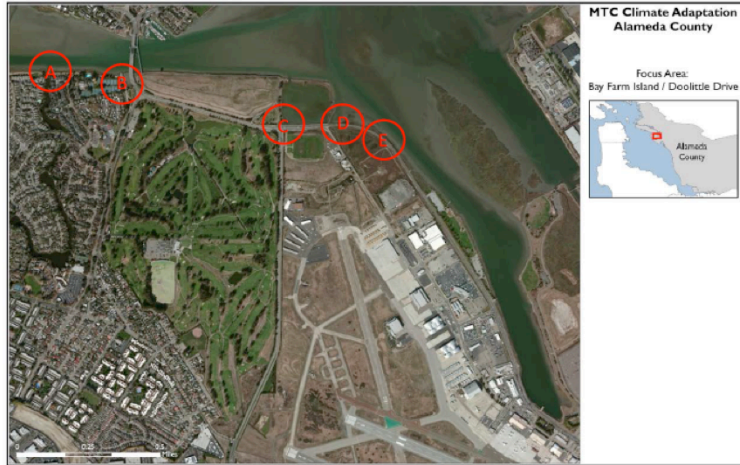
Figure 3. Sites In The DEM Contributing To Inundation In Low SLR Scenario

## Future Flood Risk (AECOM)

Table 3: Modified Low-Lying Areas in the DEM Contributing to Inundation

This areas aren't QUITE as low as we thought-remember Kris walking through the revised inundation? They are still very low. 36" is a 50 year water level here-48" isnt necessarily impossible in present day (although it is >100-yr coastal event).

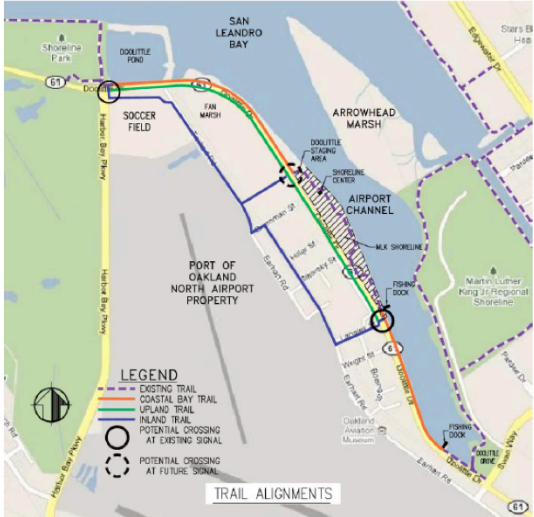
## COASTAL ALIGNMENT

# Proposed Bay Trail Alignment

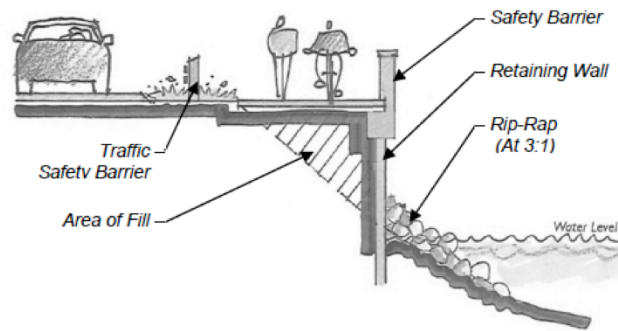
### B. EMBANKMENT WIDENING BY RETAINING WALL TRAIL TYPE

#### Conceptual Engineering Design Features

Retaining Wall with Soldier Pile and Lagging Wall or Precast Concrete Sheet Pile

\$3800-6800/linear foot (21-38 Million total). Could provide flood protection improvements

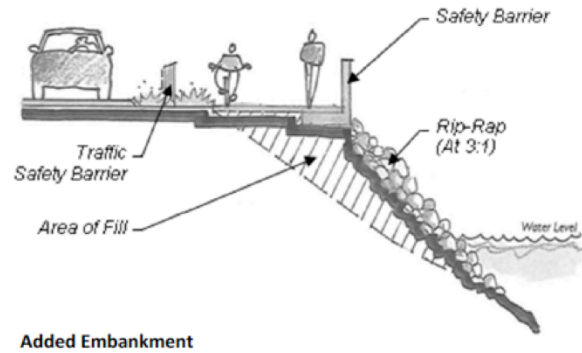
### C. ADDED EMBANKMENT TRAIL TYPE

\$2800/linear foot, \$15M total, could provide flood mitigation benefits

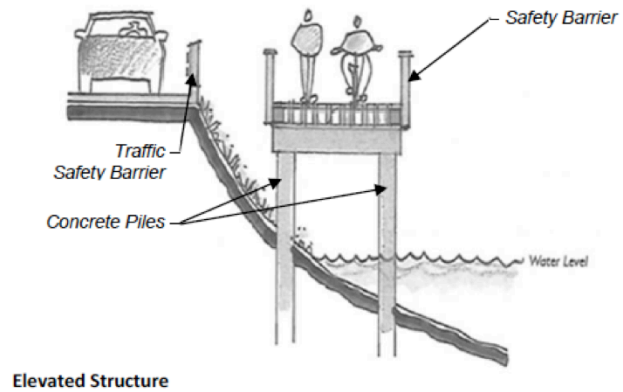
### D. ELEVATED STRUCTURE TRAIL TYPE

\$2900/linear foot, \$16M total, no flood mitigation benefits.

Segment C1 will use the existing sea wall  
Segment C2 proposes elevated structure (D) which doesn't provide flood protection

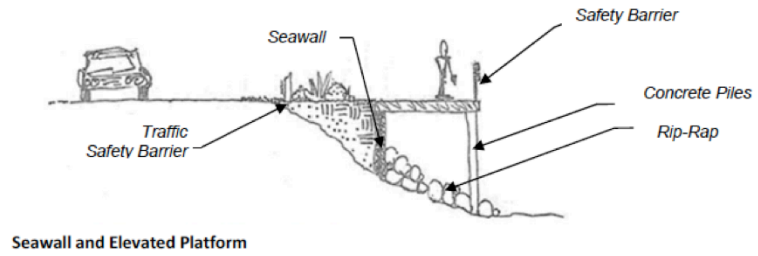
### E. SEAWALL AND ELEVATED PLATFORM TRAIL TYPE

\$5100/linear foot, \$29M total, could provide flood mitigation benefits.

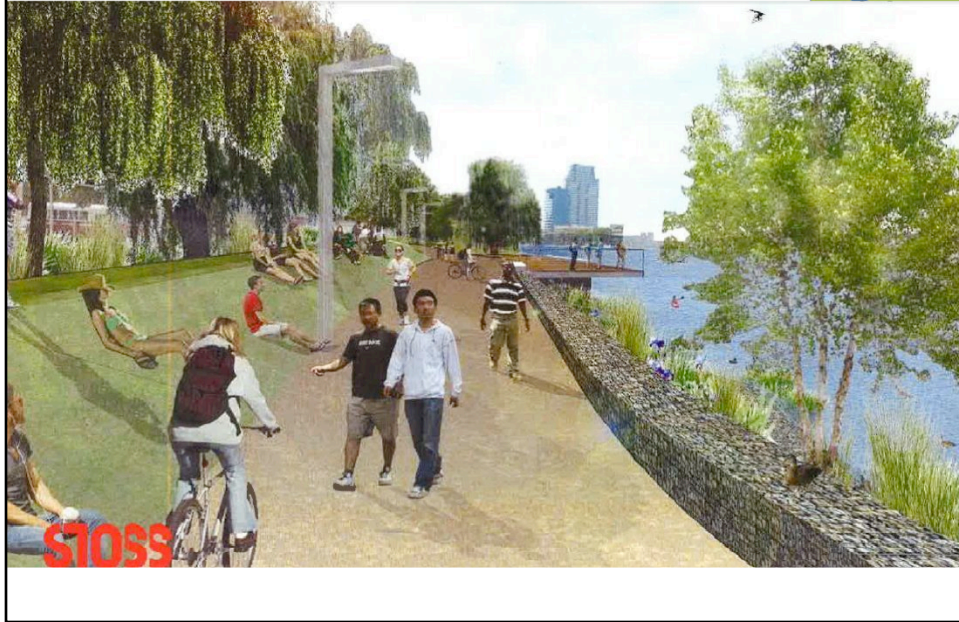
## Trails as Flood Protection

Michigan example, trail replacing cement flood wall. Normal river conditions are contained and the trail functions. The berm landside of the trail is the extreme flood protection.
